IN-1185
October 1968

CORROSION EXPERIENCE WITH TYPE 316 STAINLESS STEEL
IN SODIUM-POTASSIUM EUTECTIC ALLOY AT 1400°F

IDAHO NUCLEAR CORPORATION
NATIONAL REACTOR TESTING STATION
IDAHO FALLS, IDAHO

T. L. Hoffman

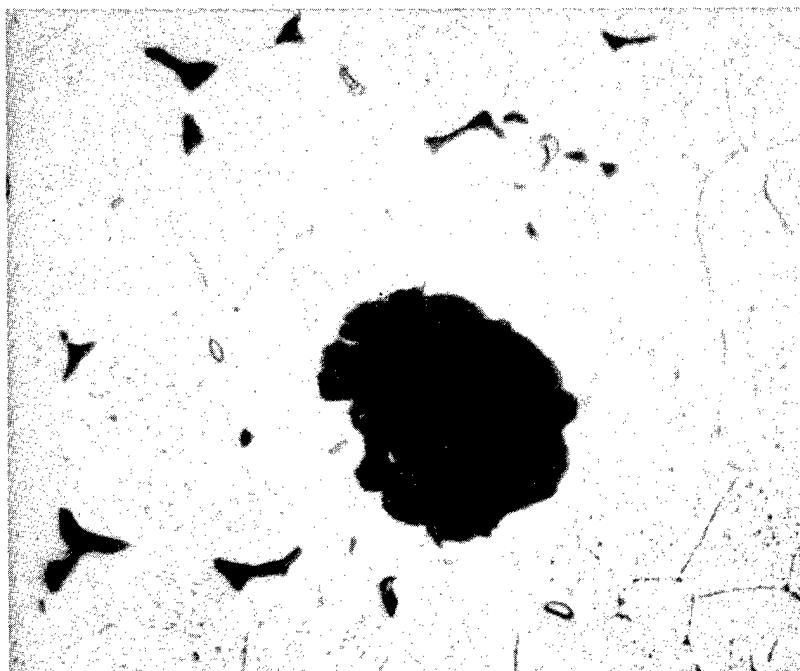
A metallographic examination of the piping indicated carbide precipitation at the grain boundaries and concentrations of up to 11 percent sigma phase as shown in Figures 6 and 7. A band of decarburized material 1 to 2 mils thick, was found on the NaK-side of the pipe wall, as illustrated in Figure 8. A 0.2- to 0.3-mil thick porous oxidation film was observed on the outer surface of the pipe wall, as illustrated in Figure 9. This film was only partially soluble in boiling nitric acid and was magnetic.

Figure 6 Sigma particle in cross-section of Type 316 ss pipe after 15,000 hours service at about 1400°F. Total Sigma is about 11%.

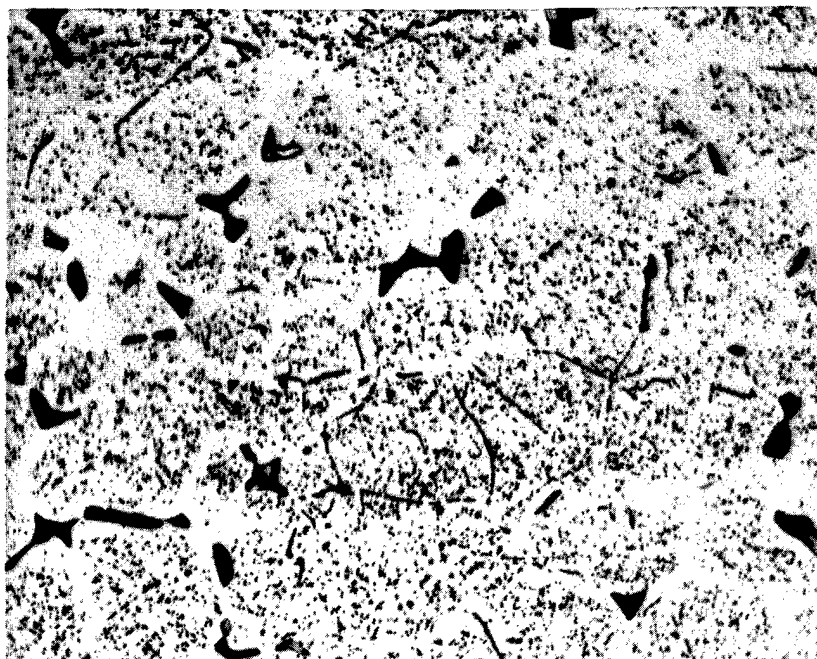
Figure 7 Cross-section of Type 316 ss pipe after 15,000 hours service at about 1400°F. Total Sigma is about 4%.

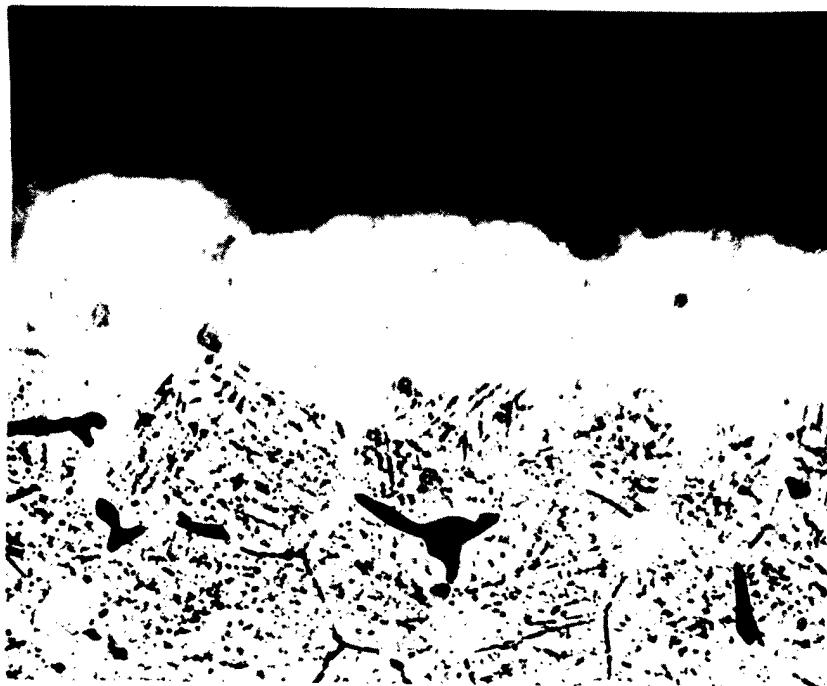
Figure 8 Decarburized zone of inside edge of 3-inch Sch. 40 Type 316 ss pipe after 15,000 hours service at about 1400°F.

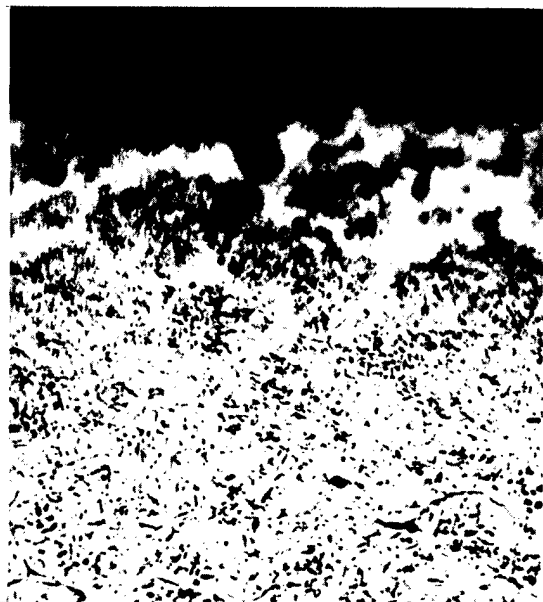
Figure 9 Air-side of Type 316 ss pipe after 15,000 hours service at about 1400°F.

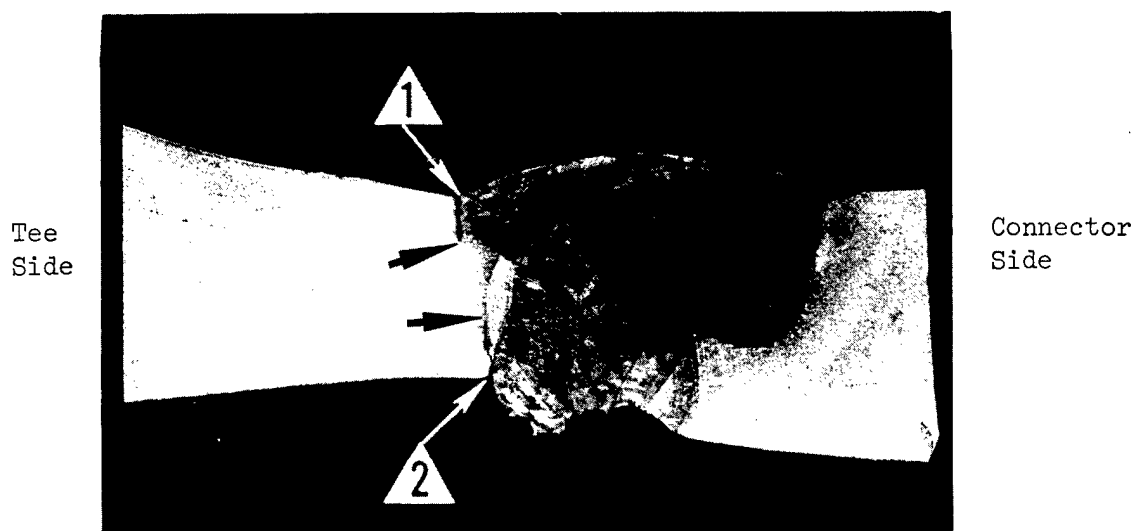
The crack on the outside of the tee-to-connector weld (tee side) was approximately 0.8-inch long. The crack on the inside of the same weld (also on the tee side) followed the edge of the weld around approximately 75 percent of the circumference. A photograph of these cracks is shown in Figure 13. In this figure, the crack on the outside penetrated 0.053 inches, the inside crack 0.047 inches, with 0.080 inches of sound metal between the crack terminations. The crack on the outside originated at the base of the weld bead at a sharp re-entrant angle. A further inspection showed the presence of a crack on the inner wall of the connector, Figure 14. The crack originating on the outside was lined with an oxide deposit while the inside crack was free of oxide. The three cracks were transgranular, as can be seen in Figures 15 and 16. A second transgranular internal (NaK side) crack, shown also in Figure 14, was found in the wrought pipe that was about ½-inch from the tee-to-connector weld.

Figure 13 Cross-section through tee connector weld. White arrow 1 shows outside crack. White arrow 2 shows inside crack. Black arrows indicate crack terminations.

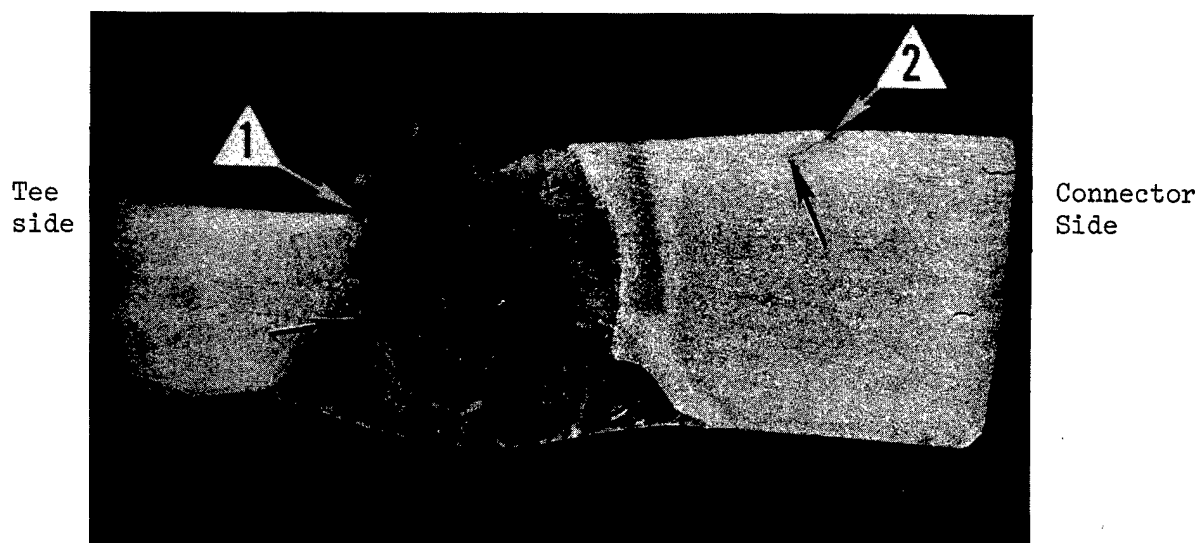
Figure 14 Cross-section through wrought connector. White arrow 1 shows crack on the inside at the base of the weld bead. White arrow 2 shows additional crack found on the inside of the connector. Black arrows indicate crack terminations.

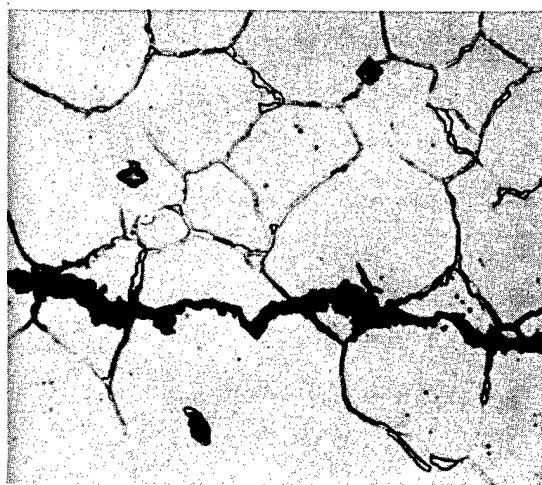
Figure 15 Internal crack in wall of pipe tee connector showing transgranular propagation after 15,800 hours service at about 1100-1400°F.

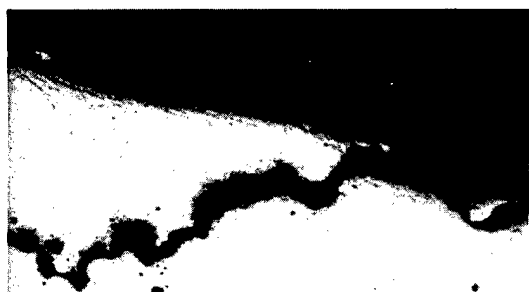
Figure 17 Internal crack in wall of connector. (Same area shown in Figure 16.)

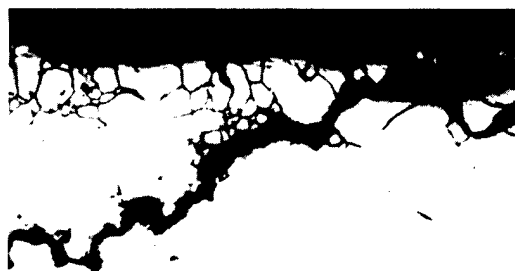
Figure 18 Internal crack in wall of connector. (Same area shown in Figure 16.)

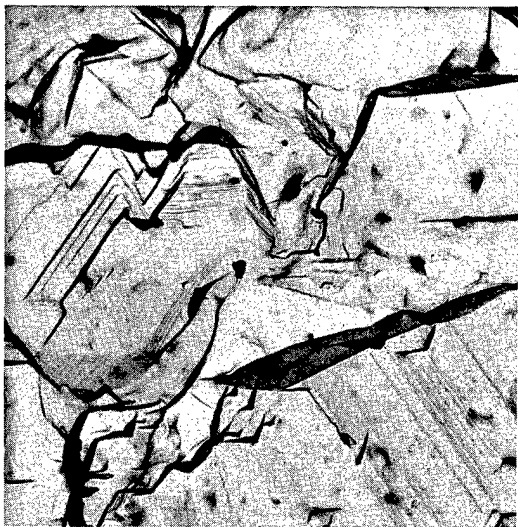
Figure 21 Surface topography of outside crack at the pipe tee connector weld.

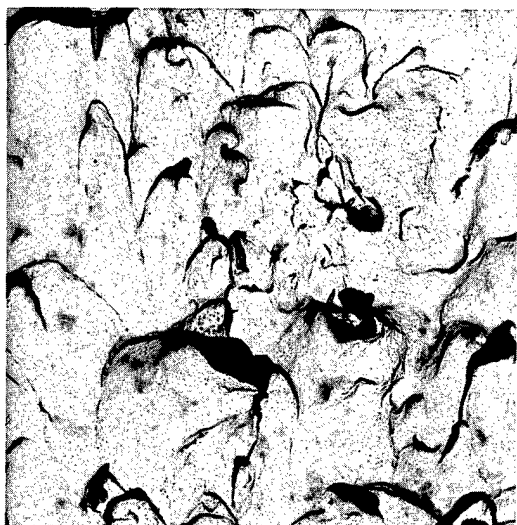
Figure 22 Surface topography produced by tearing material beyond the crack.

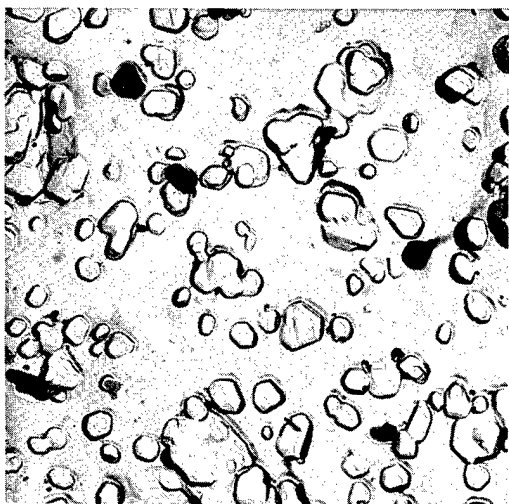
Figure 23 Surface topography of inside crack at the pipe tee connector weld.

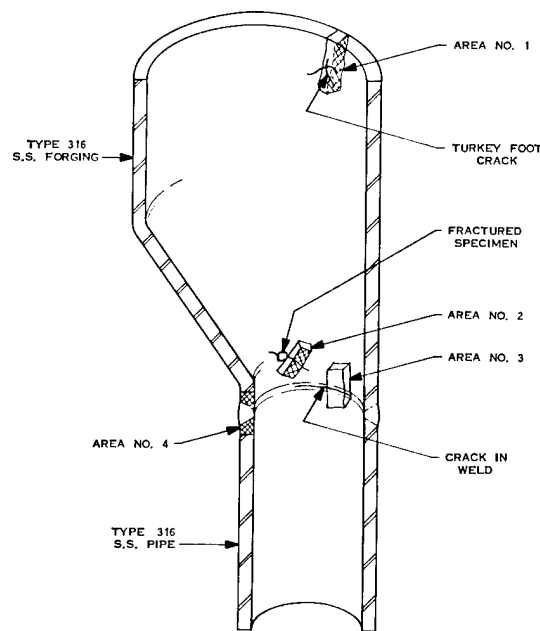
An investigation of the failure that occurred in the NaK drain line of the WCF indicated that residual and/or applied stresses cracked an eccentric reducer (Figure 24) in a manner characteristic of a brittle fracture. The weld joining this forged reducer to the 1 1/2-inch pipe suffered a ductile thermal fatigue fracture. Service time on this fitting was 19,080 hours at 1100-1400°F and 1,300 hours below 1100°F. There were 43 starts from room temperature.

Post-failure examination revealed two cracks in the reducer, and another crack in the weld that joined the reducer to the 1½-inch pipe. Both reducer and pipe were Type 316 stainless steel. Figure 24 shows the location of the three cracks. The cracks located at areas 2 and 3 in Figure 24 completely penetrated the forged reducer and weld, respectively, while the turkey-foot crack in area 1 was about 77 mils deep. Both cracks in the reducer were next to welds.

Figure 24 Diagram of 3-inch x 1½-inch eccentric reducer.

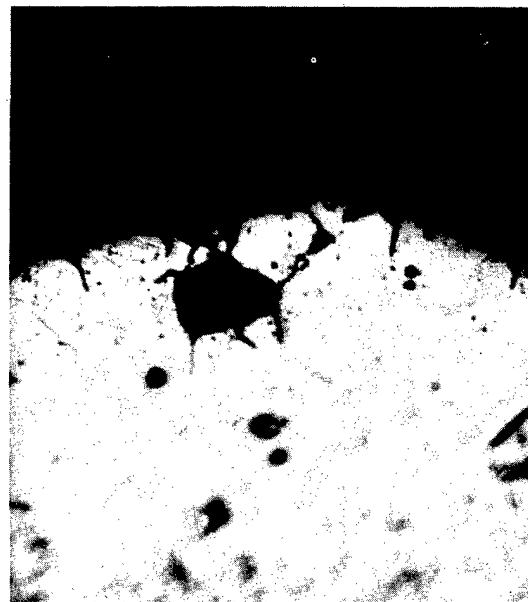
Figure 26 Grain dropping in the decarburized zone of the reducer at Area #1 in Figure 24 after 19,100 hours at about 1100-1400°F.

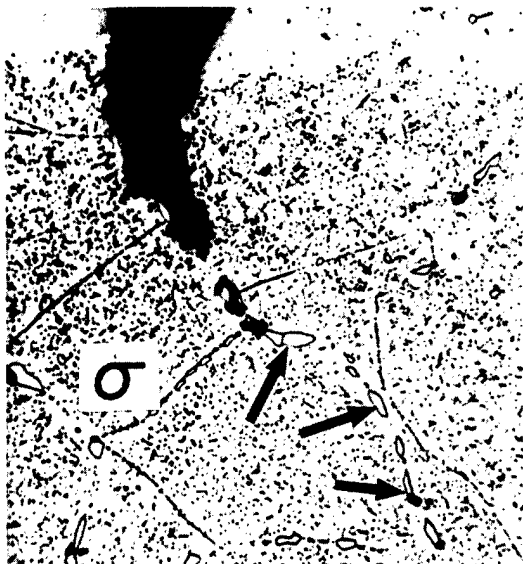
Figure 27 Root of the turkey foot
crack on the inside surface of the
reducer at Area #1 in Figure 24
showing sigma phase formation after
19,100 hours at about 1100-1400°F.

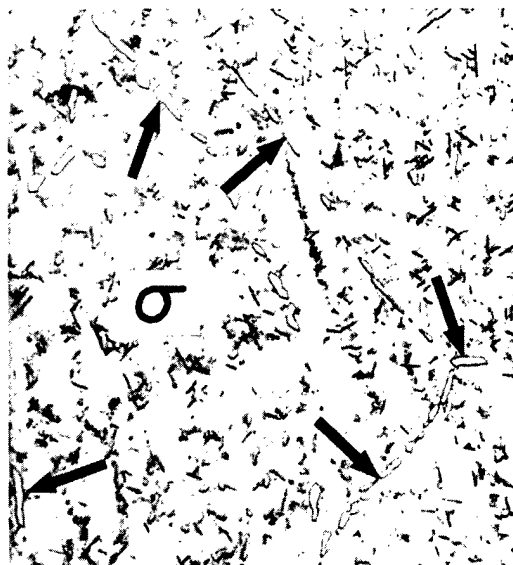
Figure 28 Weld at Area #4 in Figure
24 showing sigma phase formation
after 19,100 hours at about 1100-
1400°F.

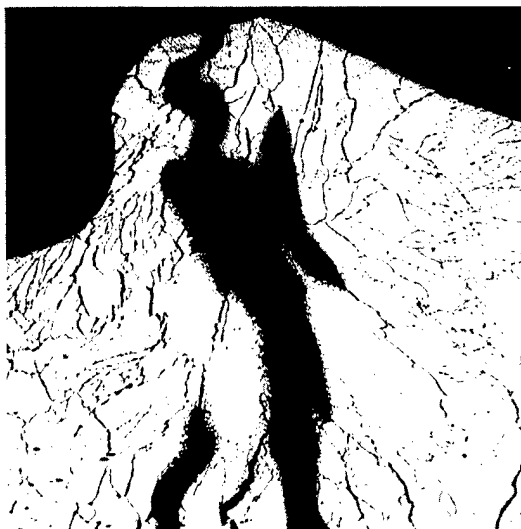
Figure 29 Cross-section of forging
at Area #2 in Figure 24 showing
intergranular fracturing after
19,100 hours at about 1100-1400°F.

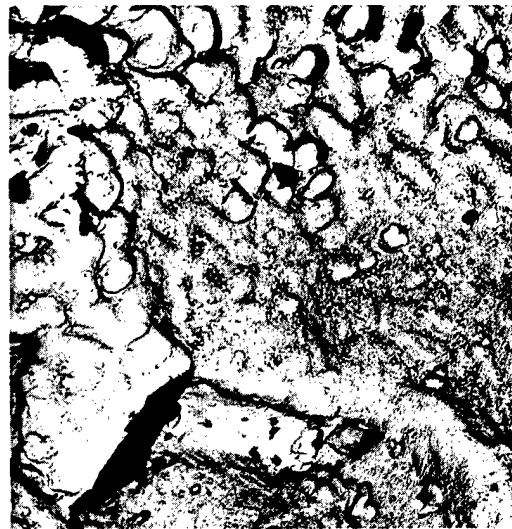
Electron microscopic fractographs of the fracture in the weld are typified by elongated dimples, Figure 30. These data suggest that shearing forces were imposed upon the weld, causing a ductile fracture. The fracture in the eccentric formed reducer has a cleavage type profile, Figure 31. This suggests that a brittle fatigue mechanism fractured the reducer.

Figure 30 Surface topography of the
weld failure at the reducer to 1-
inch pipe after 19,100 hours service
at 1100-1400°F showing elongated
dimples of ductile fatigue.

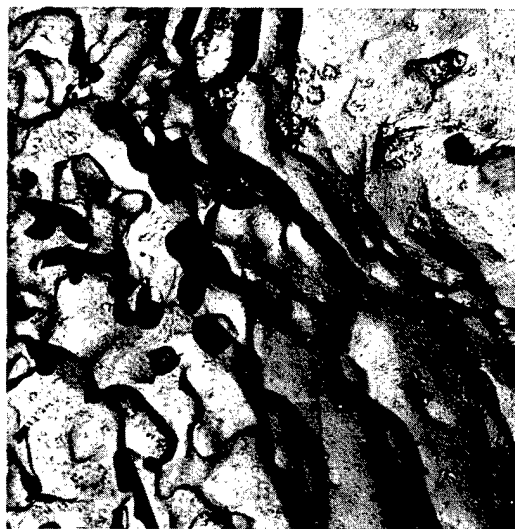
Figure 31 Surface topography of the crack of the forged reducer at Area #2, after 19,100 hours service at about 1100-1400°F showing both elongated or tear dimples of ductile fatigue and intergranular brittle fatigue.

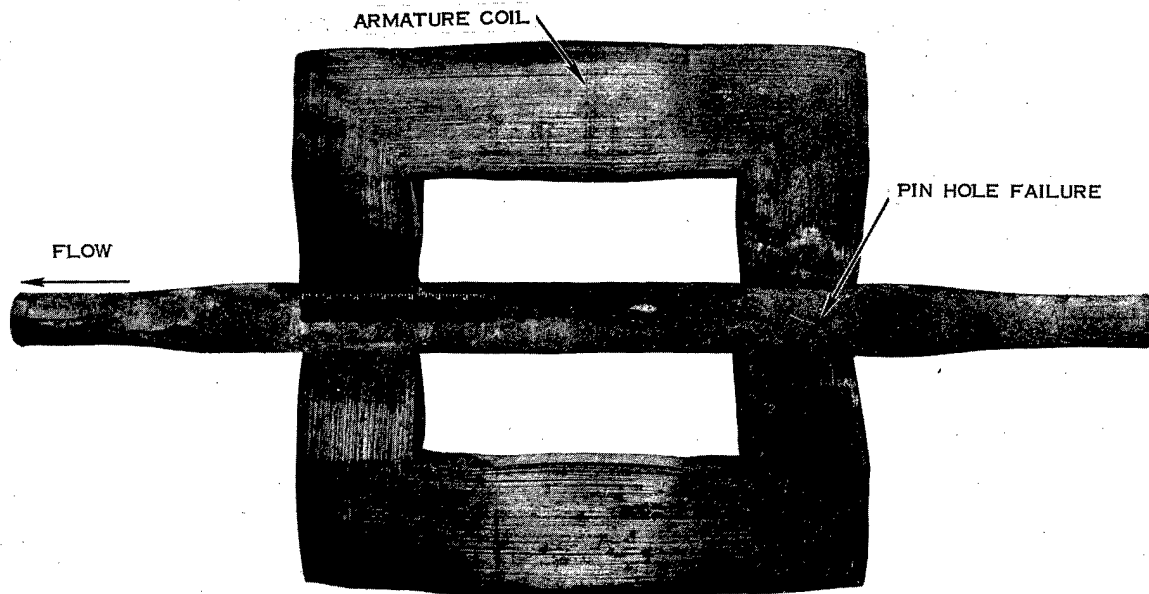
There is no complete explanation for this failure; although, there is considerable evidence of carburization of the pump tube, and this is an area where cavitation could occur.

Figure 33 Dismantled NaK electromagnetic pump tube and armature coil.

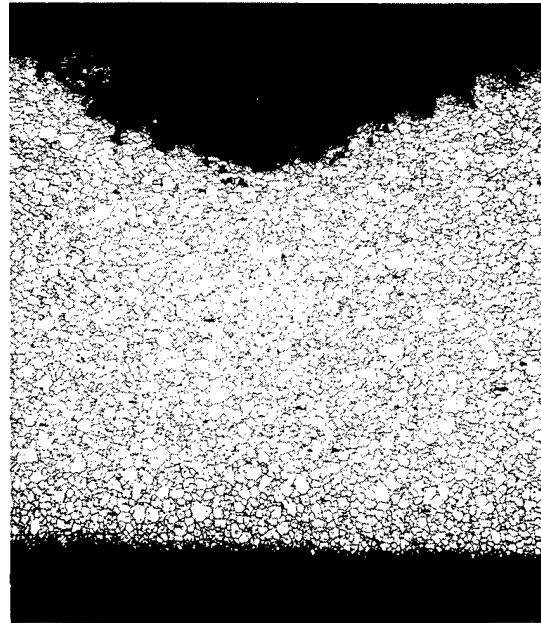
Figure 36 Cross-section of pit in NaK pump tube after 20,100 hours at about 1022-1400°F.

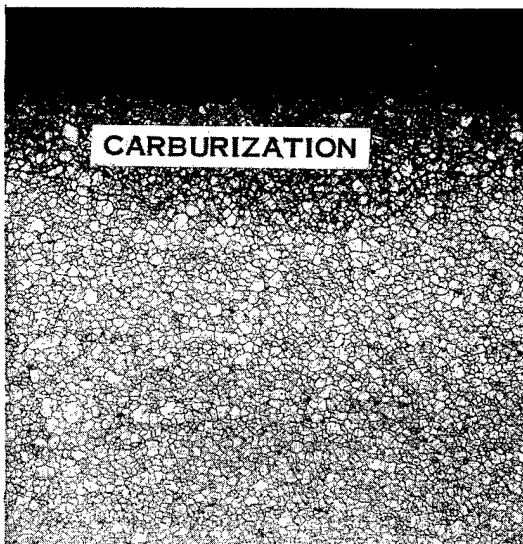
Figure 37 Cross-section of EM pump tube showing a carburization band on the NaK side of pump tube after 20,100 hours at about 1022-1100°F.
